**State of California  
The Resources Agency  
DEPARTMENT OF WATER RESOURCES  
DIVISION OF FLOOD MANAGEMENT**

**2004  
PROJECT STRUCTURE REPORT**

**INSPECTION OF  
FLOOD CONTROL STRUCTURES ON THE  
SACRAMENTO AND SAN JOAQUIN RIVERS  
AND THEIR TRIBUTARIES**

**Prepared By The  
Flood Operations Branch  
Flood Project Inspection Section**

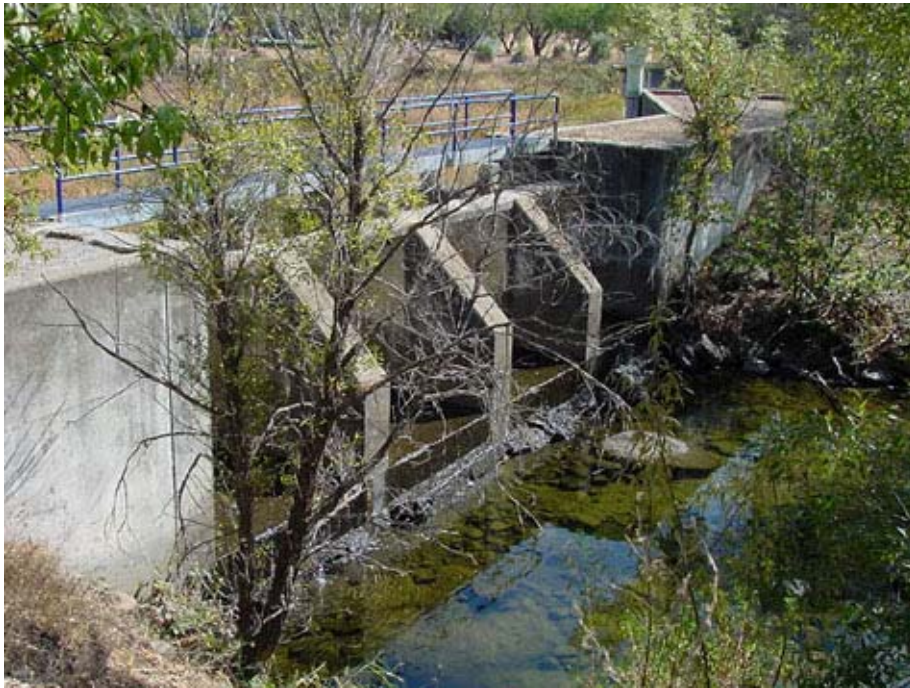
- 1. Condition of concrete control structure.**
  - a. Fair. The base at the downstream side of the control structure is beginning to undermine.**
- 2. Condition of bulkheads and wing walls of the control structure.**

**The downstream side of the control structure.  
Repairs have not been made to prevent undermining of the structure.**

- a. Repair the control structure base (downstream side) as soon as possible.**
- b. Continue to monitor joint separation between the control structure and the abutments and repair as needed.**
- c. Remove driftwood and cobbles from dissipaters.**
- d. Remove small trees in front of dissipaters.**
- e. Fair maintenance.**

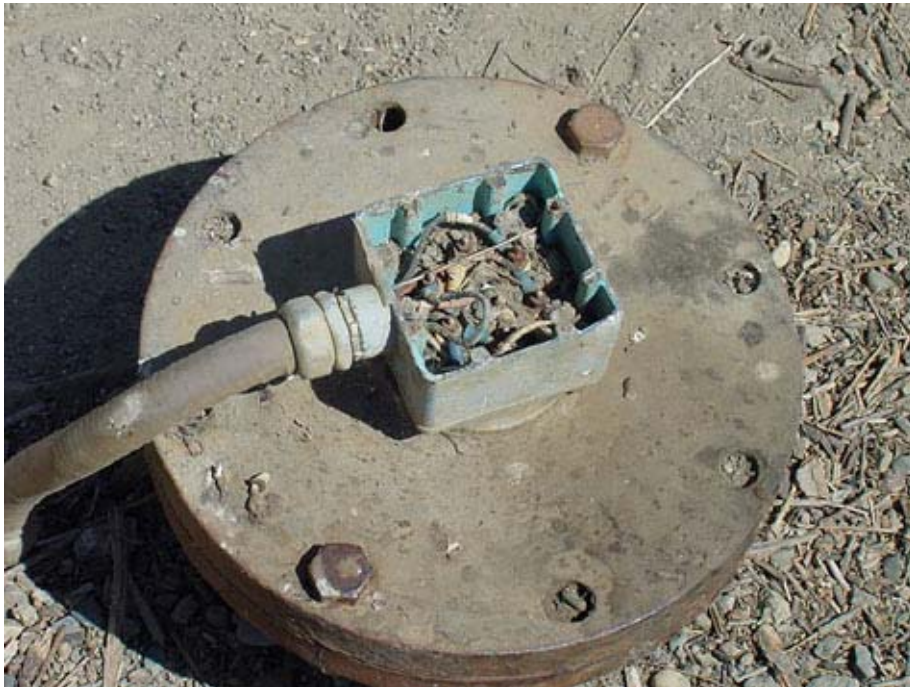
**Electrical wire exposed.**

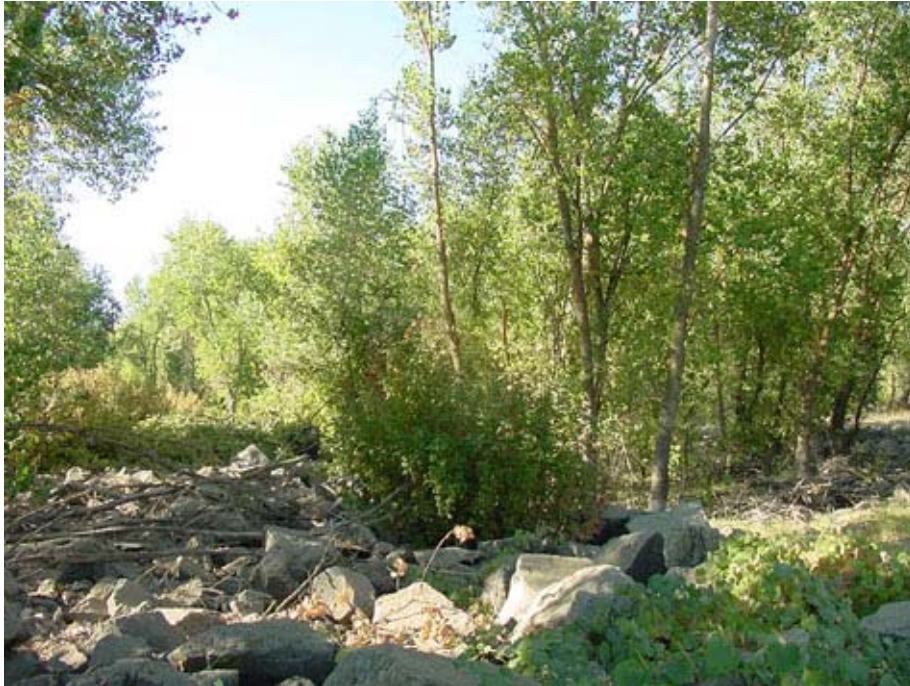
**Southwest at the growth and debris on the rock weir.**

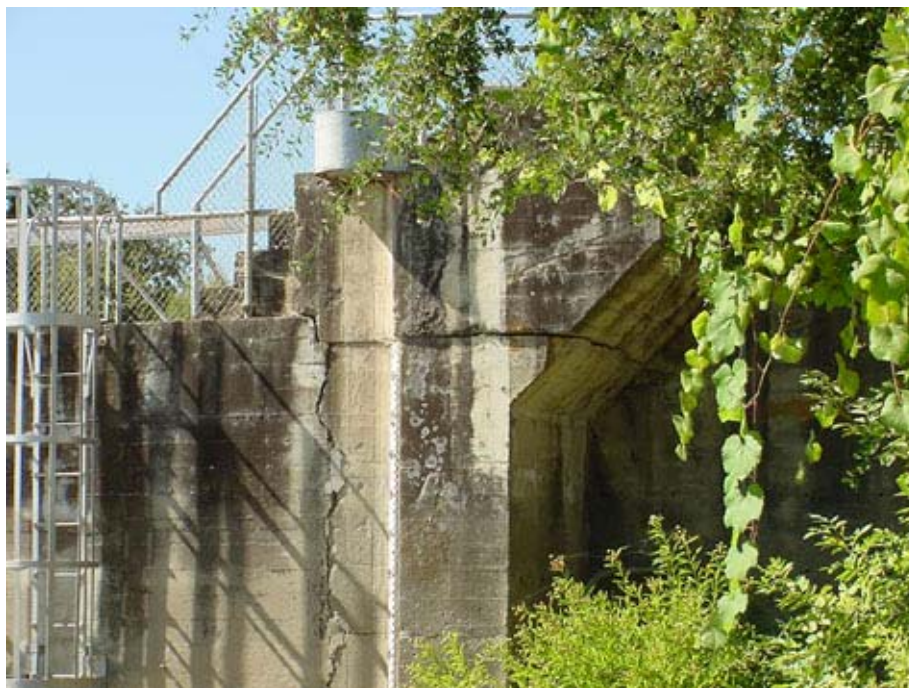
- 1. Condition of outfall structure.**
  - a. Good.**
- 2. Condition of bulkheads.**
  - a. Fair. The large vertical crack and displacement on the downstream side, left bank, has not changed in several years. The crack is not accessible for measurement, but the overall width is estimated to be 1 inch.**

**There is a vertical crack and displacement on the downstream side of structure.**

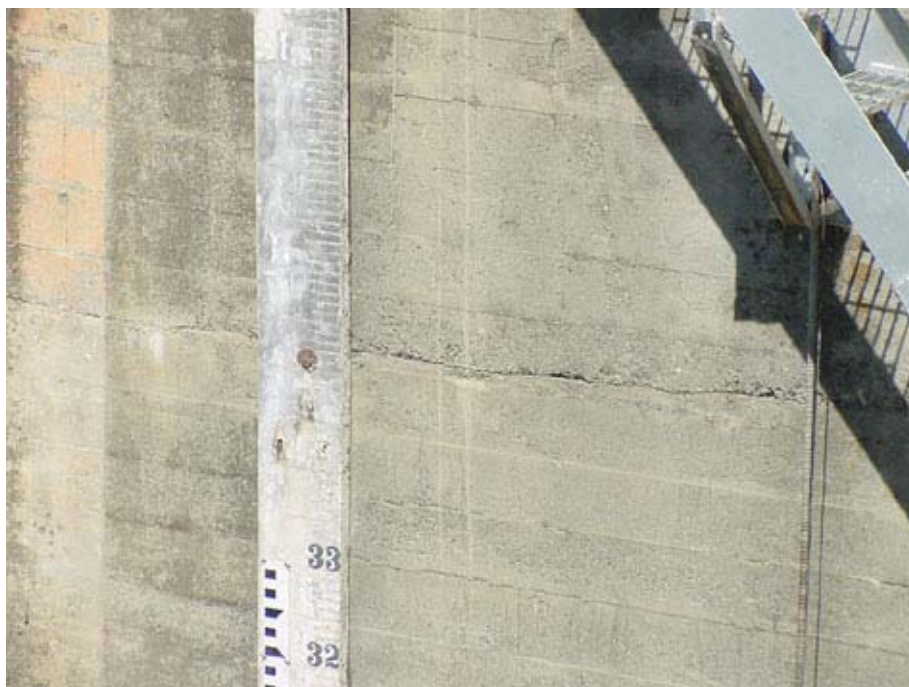
- c. Horizontal crack on the upstream left bulkhead.**
- 3. Condition of the pipes.**
  - a. Good.**
- 4. Condition of the control gates, mechanisms, and flap gates.**

**Horizontal crack on the upstream left bulkhead.**

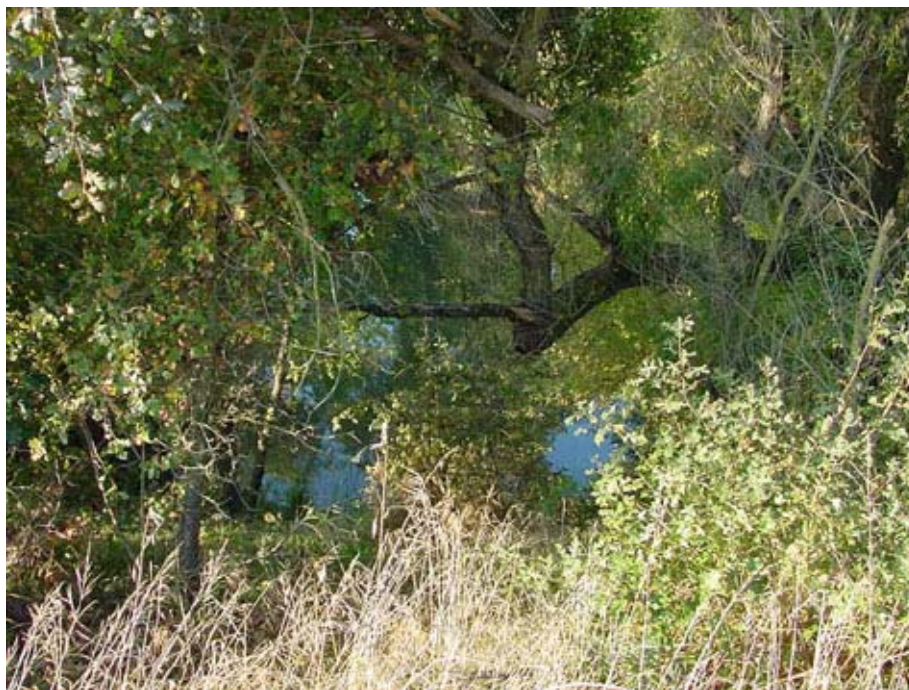
**View of the discharge side into Elk Slough.  
The structure is under water.**

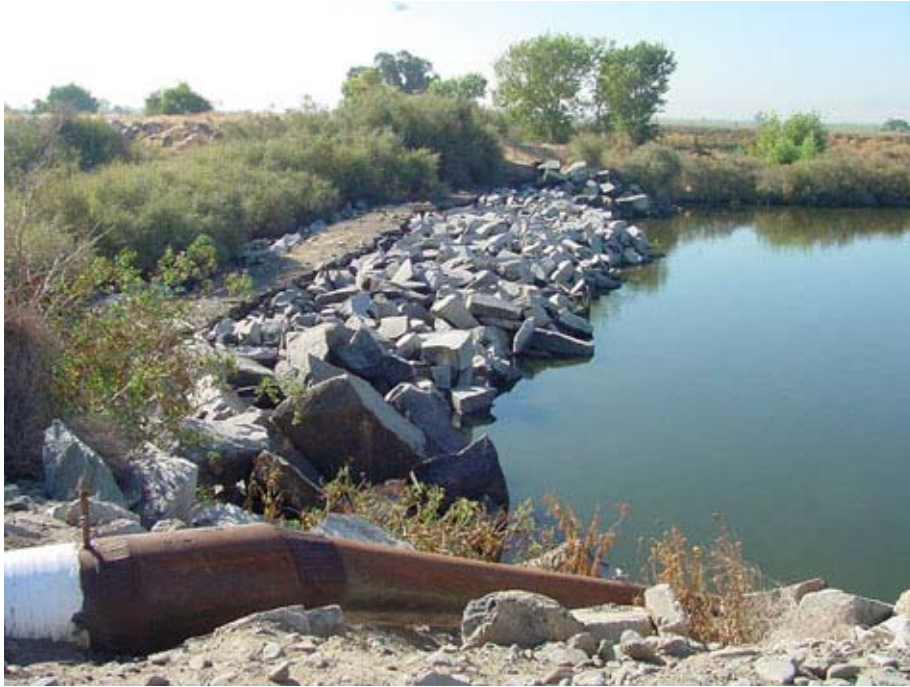
**The upstream side of the dam.  
Note the willow growth in front of the structure.**

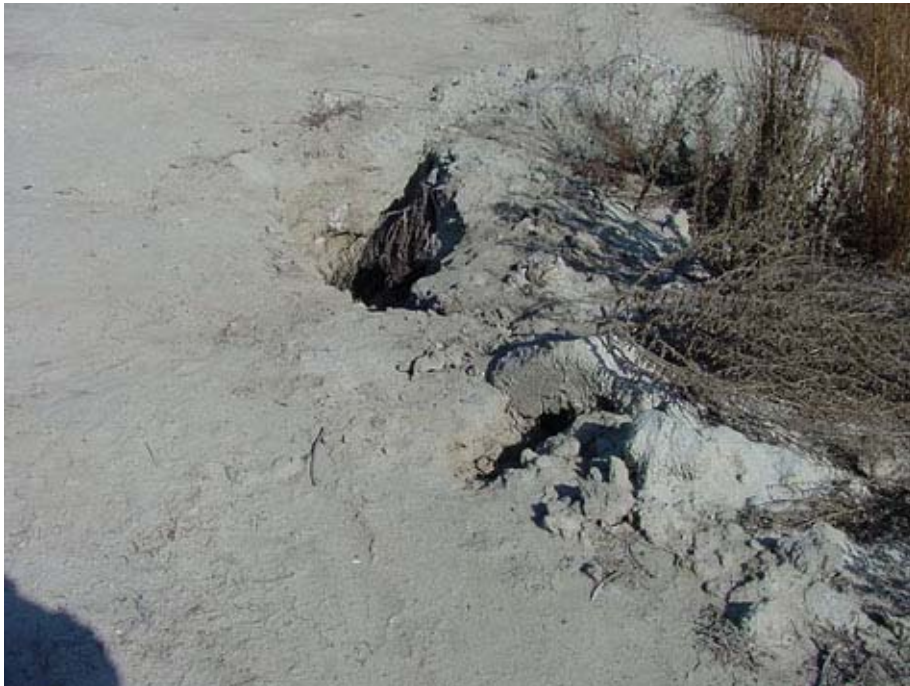
**One of several large holes in the  
bank between the structure and the levee.  
Looks like there has been some repair work, but still a problem.**

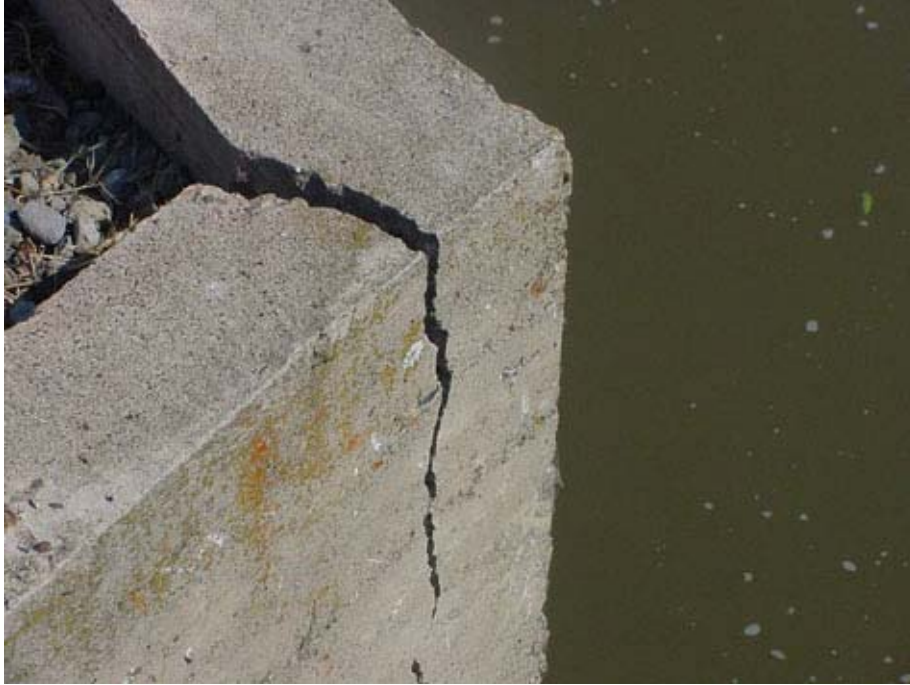
**The 2 inch crack in the right bank abutment on the upstream side. The left bank abutment is also cracked.**

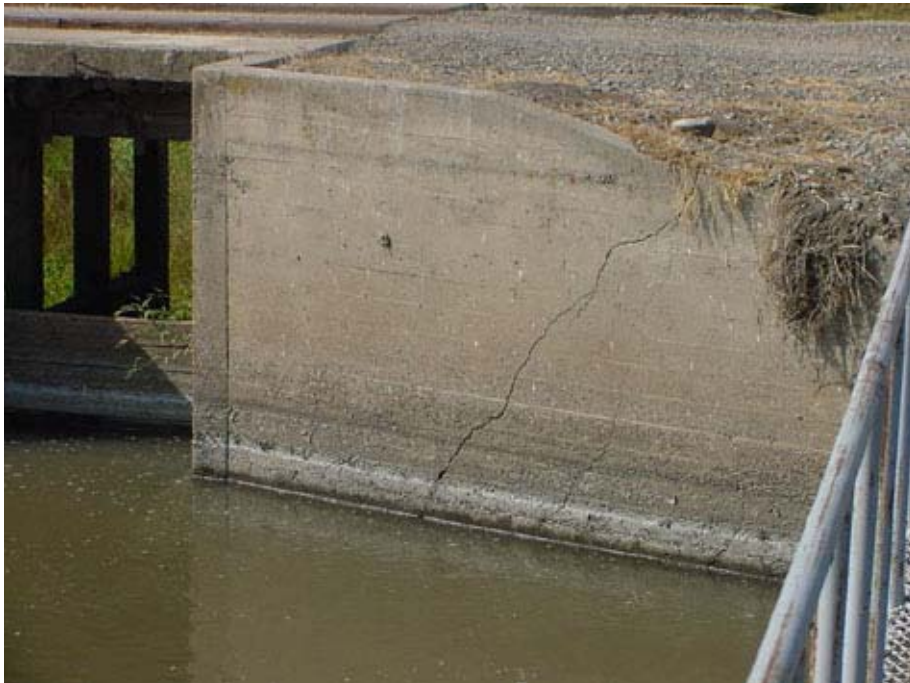
**North west wing also cracking.**

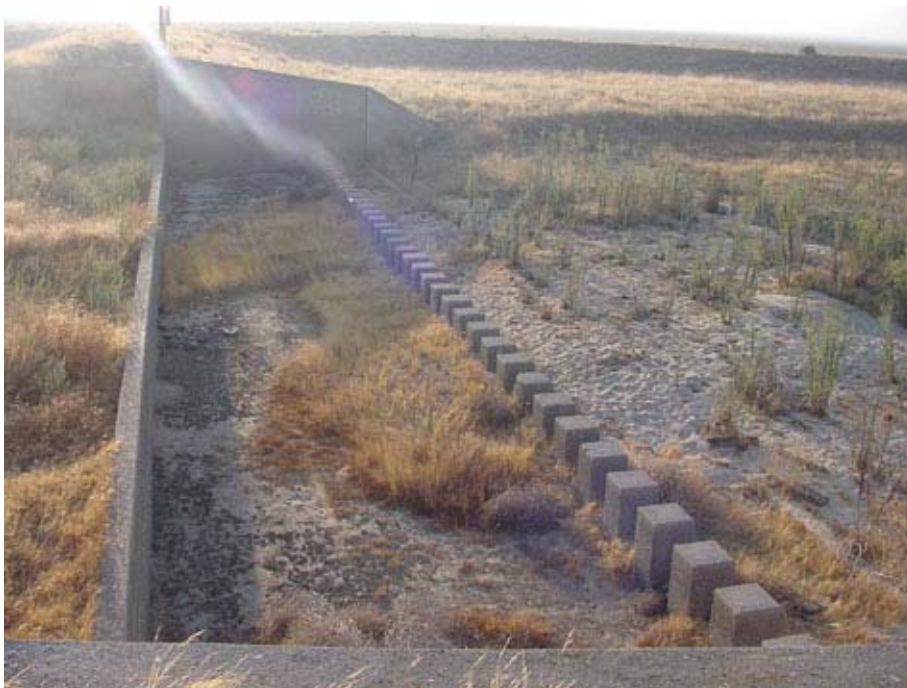
**The downstream side of the structure.  
Sand is accumulating in the stilling basin.**

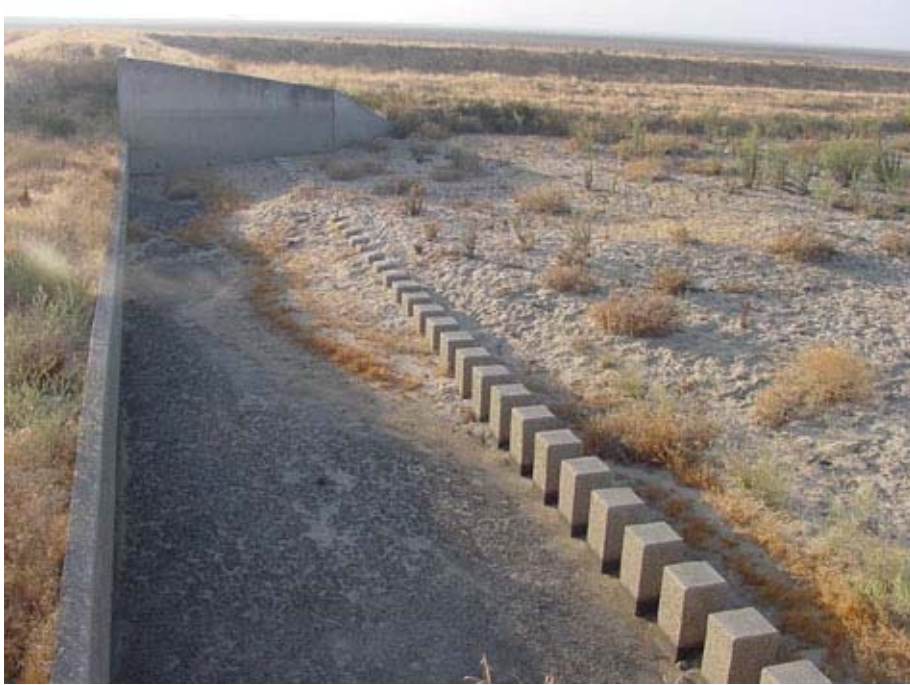
**The partially sand filled stilling basin.  
The velocity dissipaters are covered by sand.**
